Subject: Phase I Environmental Site Assessment  
Old Can Dump  
CTH K  
Chenequa, Wisconsin  
MES Project No. 7-41083

**PHASE I ENVIRONMENTAL SITE ASSESSMENT**

Old Can Dump

MES Project No. 7-41083

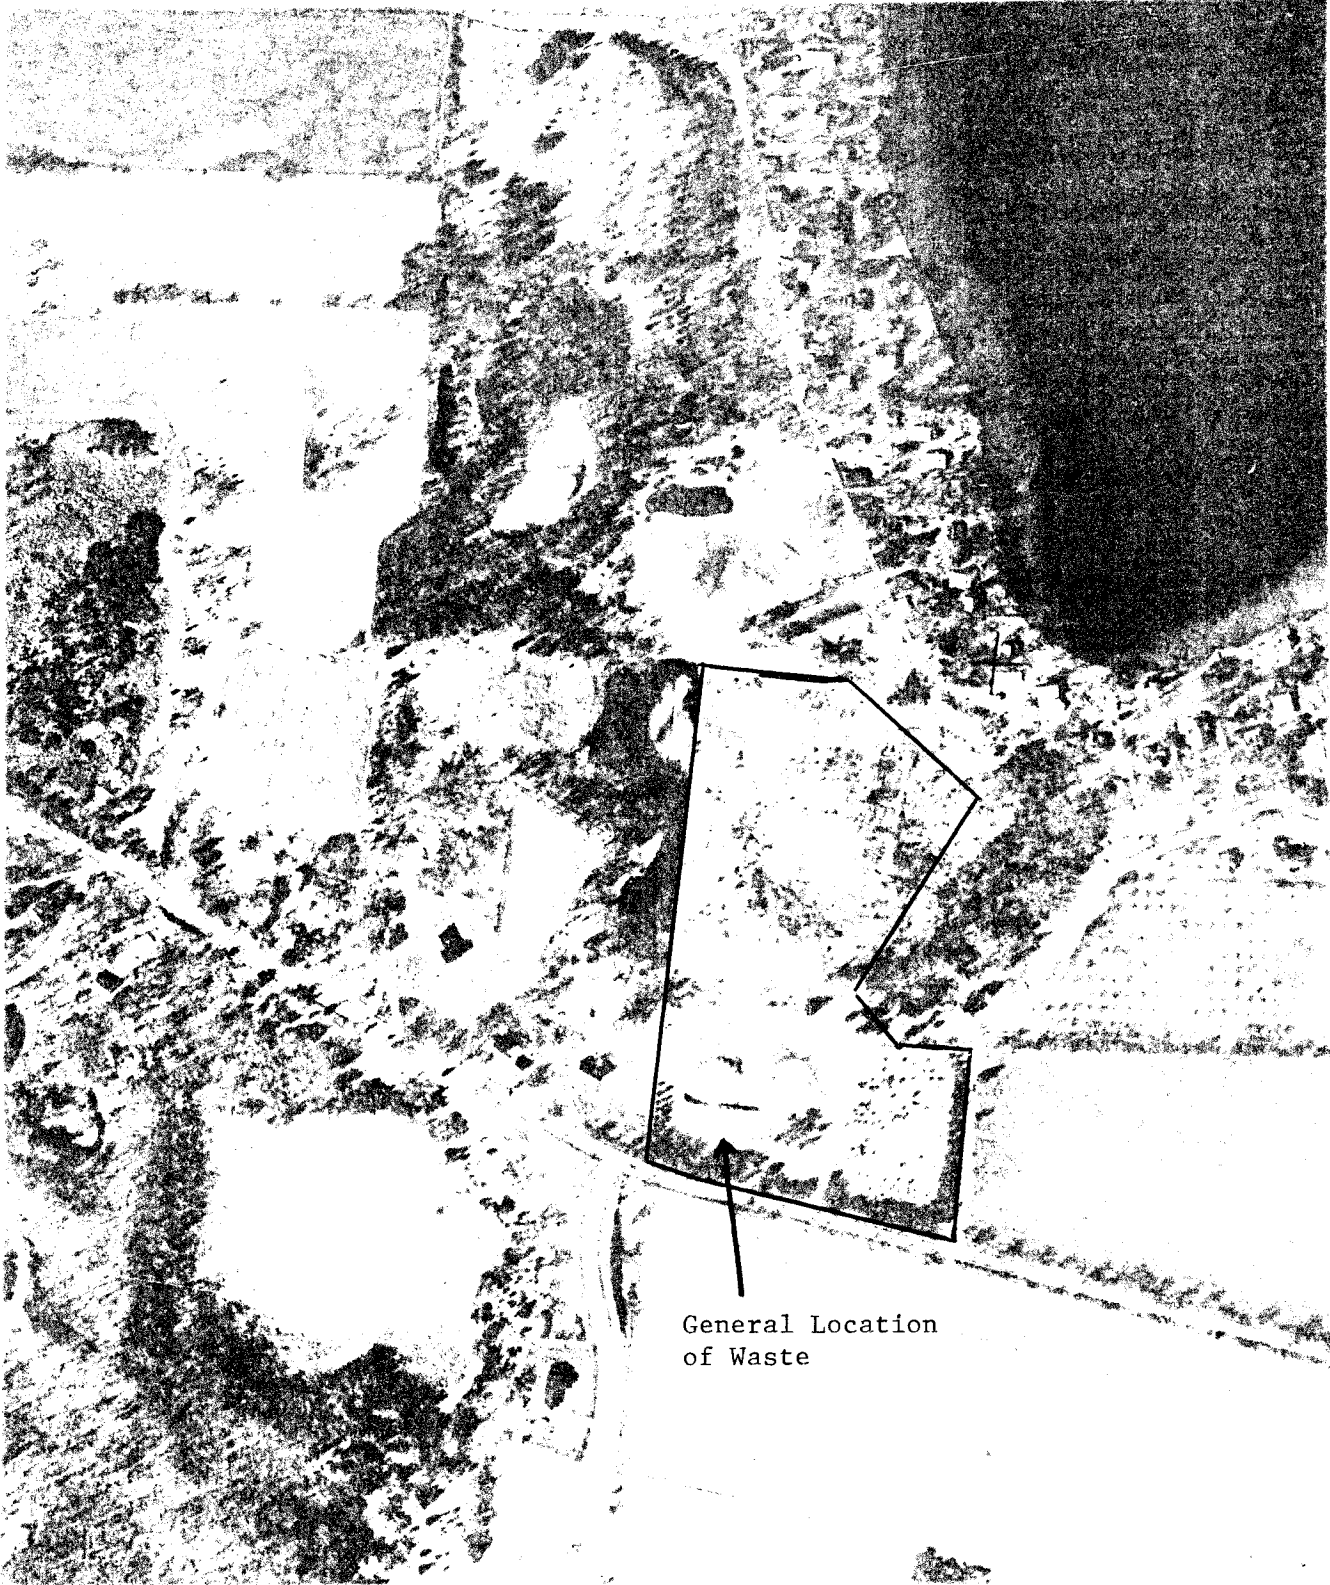
Aerial Photograph  
1967

General Location  
of Waste

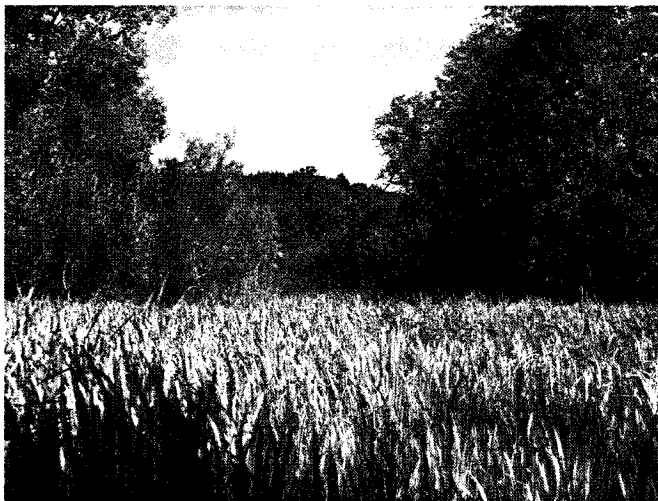
2. View of typical low, open area on the subject site.

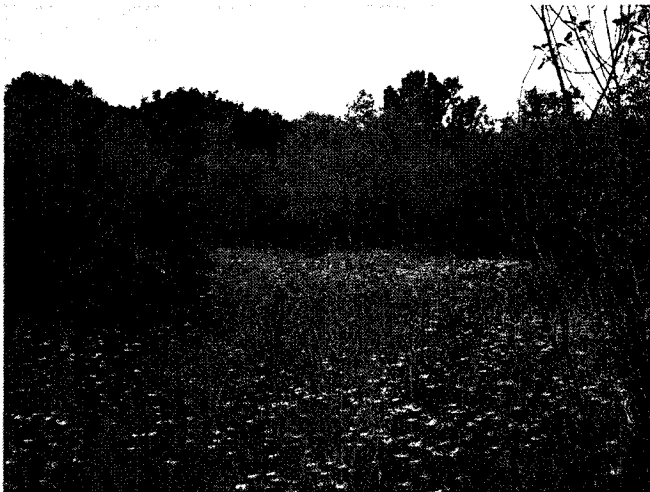
3. View of open area on the subject site.

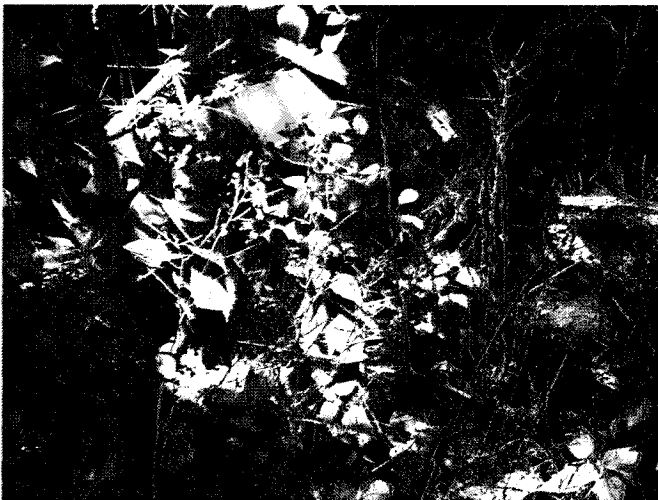
6. Photograph of partially buried metal debris observed near soil stockpile on south-central portion of site.

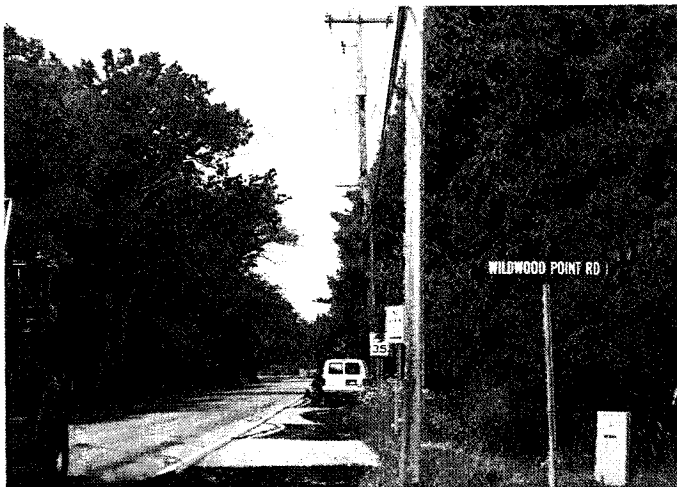
7. View of southern property boundary and southern adjoining CTH K.

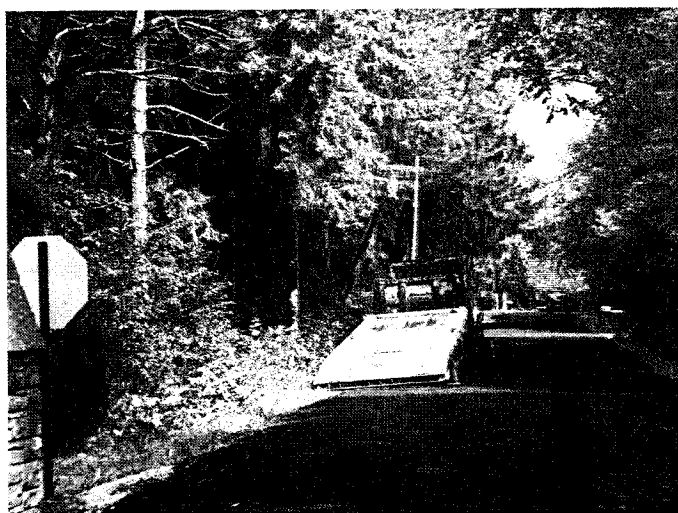
8. View of eastern property boundary and eastern adjoining Wildwood Point Road.

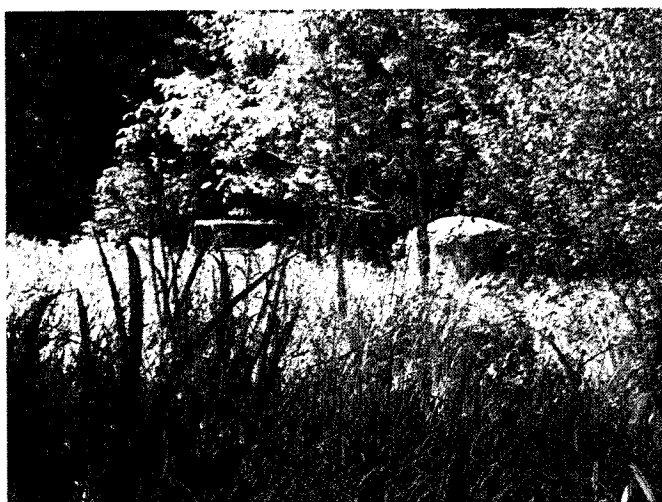
9. View of western property boundary. Truck and water tank are located on western adjoining property.
